# Analysis of conditions of the sidewalk in Ichinoya Area

Nuwan Senevirathne (Master's Program in Geosciences)

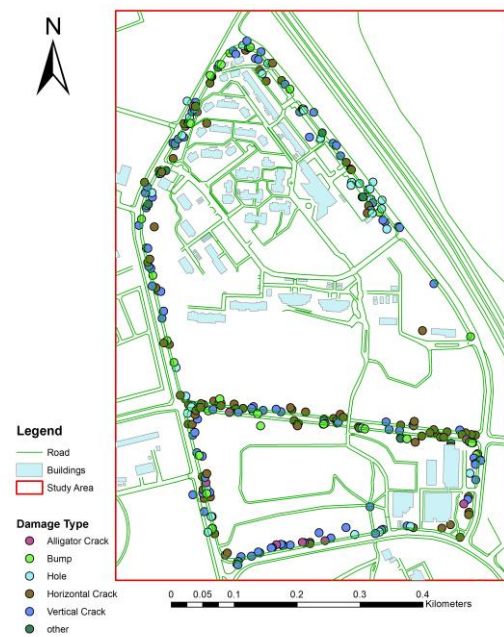
Figure 01: Damage type distribution

Figure 01 shows the Damage type distribution of the study area. According to the survey results (Figure 02), most reported damage types are Vertical Cracks (33.22%) and Horizontal Cracks (31.58%). Also, Holes (14.47%), Bumps (11.18%), Alligator Crack (6.91%) and Other (2.63%). Figure 04 shows the Damage density analysis map of the sidewalk. East side of the maps shows the less damages because of recent renovate of the sidewalk. North side of the Ichinoya dormitory area and the many places around TARA center have high density of damages.

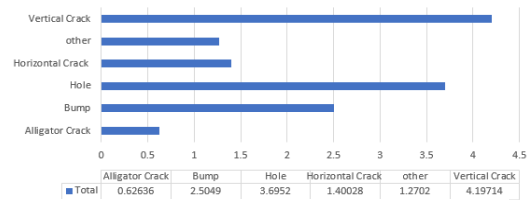
Figure 03: Sum of area by damage type

Figure 03 shows the sum of area by the damage type. vertical cracks damage area is the highest and the value is 7.19714m<sup>2</sup>, while damage area of the holes is 3.6952 m<sup>2</sup>. Bumps damage area is 2.5049 m<sup>2</sup>. Horizontal cracks damage area is 1.40028 m<sup>2</sup>. Other types damage area is 1.2702 m<sup>2</sup> and alligator crack damage area is the lowest and value is 0.62636 m<sup>2</sup>.
